Airworthiness Directives; Various Restricted Category Helicopters

AD 2012-14-11 required inspecting the main rotor mast (mast) for a crack. This new AD expands the mast inspection area, changes the inspection to a repetitive inspection, and removes the reporting requirement. The actions in this AD are intended to prevent failure of the mast and subsequent loss of control of the helicopter.

2014-22-03 **Various Restricted Category Helicopters**: Amendment 39-18008; Docket No. FAA-2014-0337; Directorate Identifier 2014-SW-029-AD.

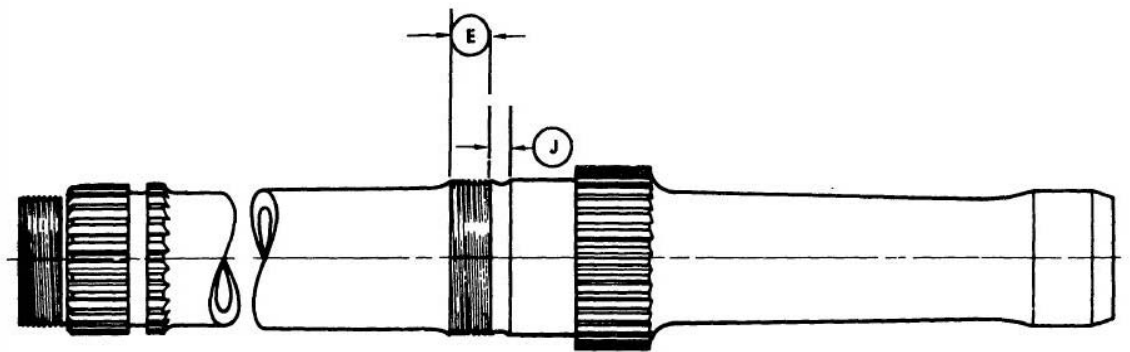
This AD defines the unsafe condition as a crack in the main rotor mast, which could result in failure of the mast and subsequent loss of control of the helicopter.

(i) Remove any surface rust with a wire brush or steel wool and, using a 10X or higher power magnifying glass, inspect the areas of the mast as shown in area E and area J of Figure 1 to Paragraph (f) of this AD for pitting, corrosion, or a crack.

(2) If there is a crack, pitting, or corrosion, before further flight, replace the mast with an airworthy mast.
